EXSITE® ENHANCED 2 SERIES 6 MP **EXPLOSION-PROOF CAMERA SYSTEM RUGGED & RELIABLE SOLUTION CERTIFIED** FOR HAZARDOUS LOCATIONS

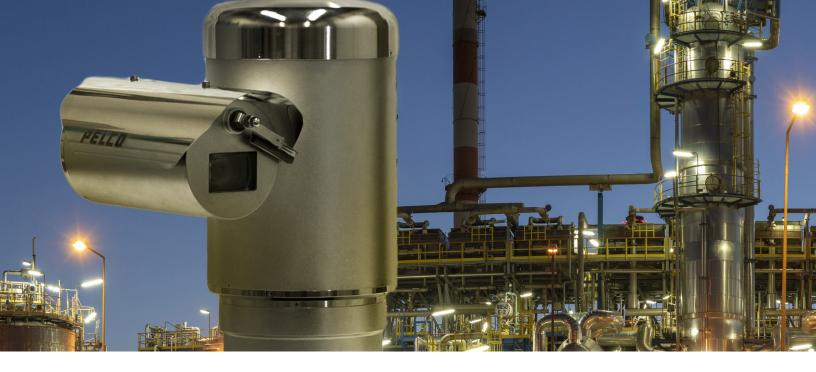
The ExSite® Enhanced 2 explosion-proof camera system is purpose-built to monitor operations and control processes in hazardous locations with risks of explosion, due to the presence of flammable liquids, gases or dust. This camera system offers form factors in PTZ, IR PTZ, bullet, and compact bullet and is built with corrosion-resistant stainless steel construction. For sites requiring strict compliance measures, this camera system adheres to international standards UL, CSA, ATEX, IECEx AND EACEx. It provides operators crisp and clear evidence with up to 30X optical zoom with true WDR and low light capabilities for challenging lighting conditions common to hazardous areas.
